Excavations at Castlehill of Strachan, 1980-81

Peter A Yeoman*

SUMMARY

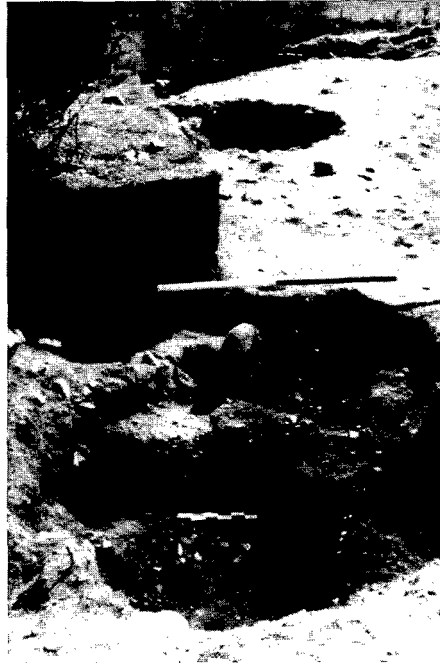
ILLUS 7 Palisade A post-pits 270 and 185

the E, the second pit possessed even, sloping sides with a 10 cm thick grey clay deposit on the base (185). This clay was very similar in nature to that used as consolidating material within the piled-up gravels, and in this case was probably used as a bedding for the post base (see illus 8, section M; illus 7).

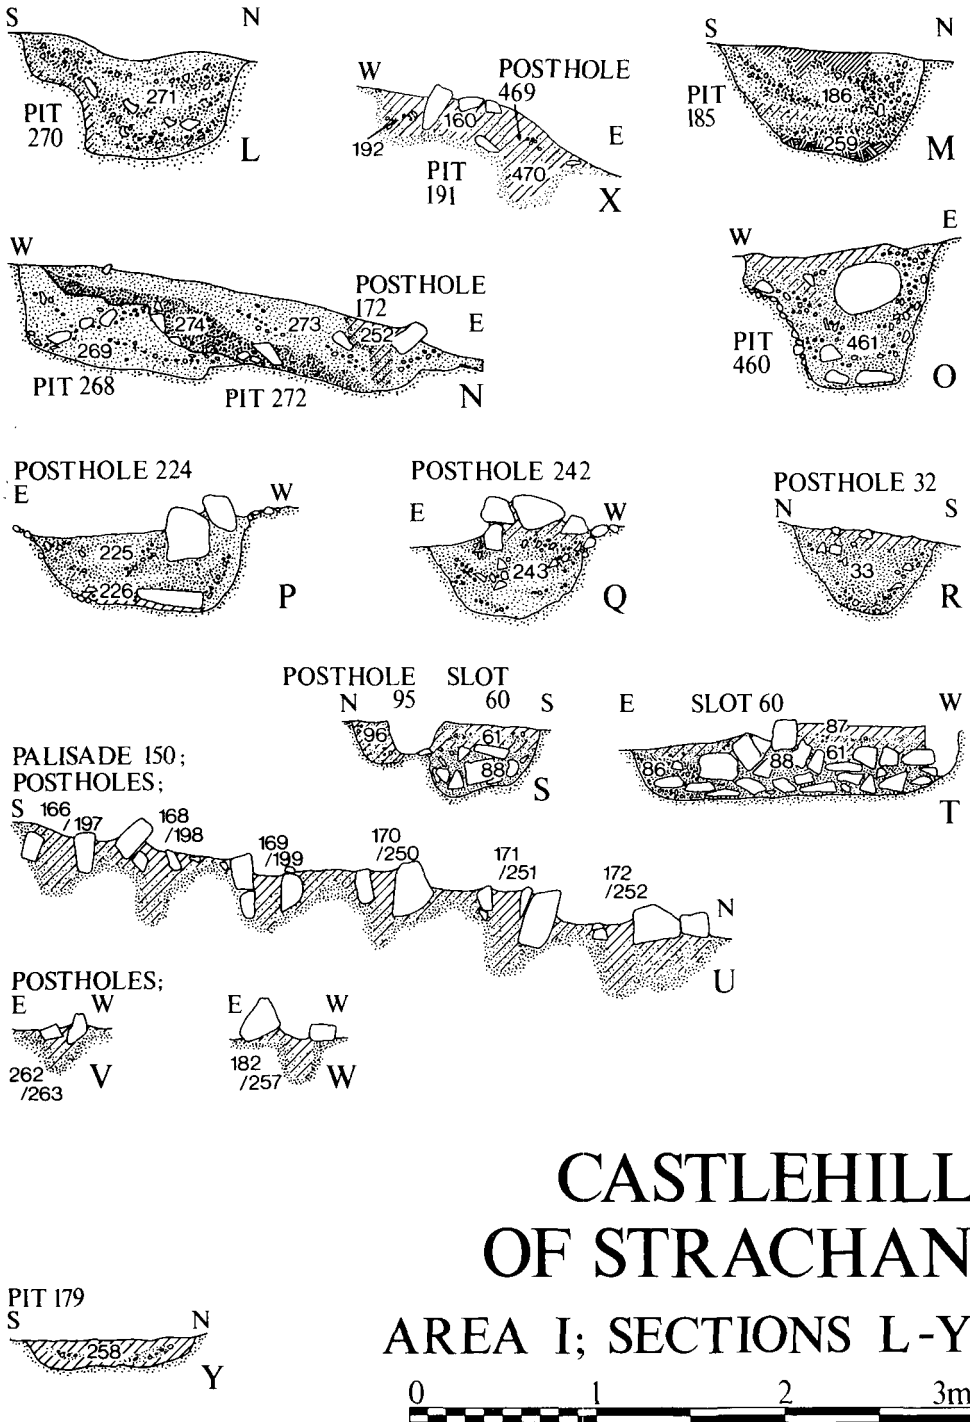
CASTLEHILL OF STRACHAN AREA I; SECTIONS L-Y

ILLUS 8 Summit sections L-Y

The third post-pit (268) was smaller, with a base which sloped down to the S, although this may have been distortion caused by recent slippage (see illus 8, section N). The fourth pit (191) was similar in size to the last and contained a contemporary posthole (469) cut through the east side of the pit base (see illus 8, section X). This was 33 cm in diameter and probably represents the size of the post held by the pit backfilling. None of the other palisade pits produced evidence of post sizes.

Three post-pits were found on the line of the proposed N-S long axis (illus 8, sections O, Q; illus 11, section C). The first and largest of these (460) was found 3 m to the NW of the most southerly of the surviving wall-posts (297). Like all these structural features, this sub-circular post-pit was cut into the compacted, natural gravel platform (65). This 70 cm deep cut was well within the building, being some 3 m N of the south end, and would have contained an internal main support, in the form of an upright timber with a probable diameter of 50 cm. Next in line to the N was a post-pit for the central timber (242). This circular cut was situated 5.5 m S of the main northern post-pit (280) and matches the proposed position of the opposite end of the building when mirrored to the S, now unfortunately lost by erosion.

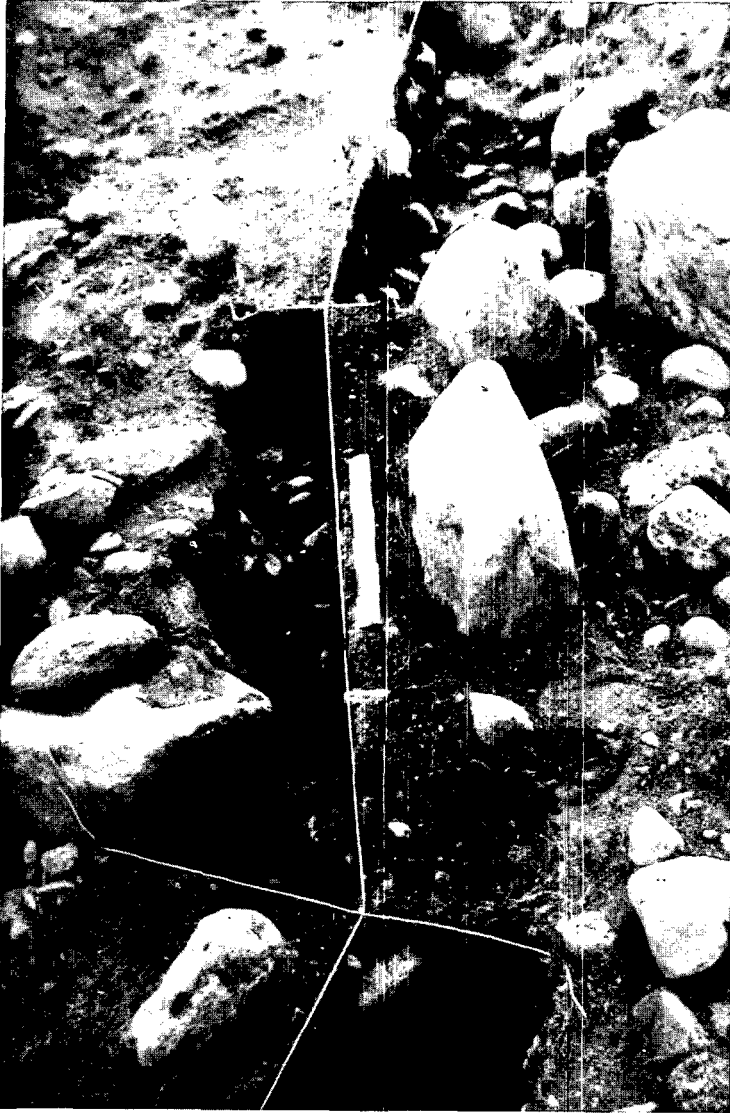
ILLUS 10 Slot 260 during excavation with stone packing

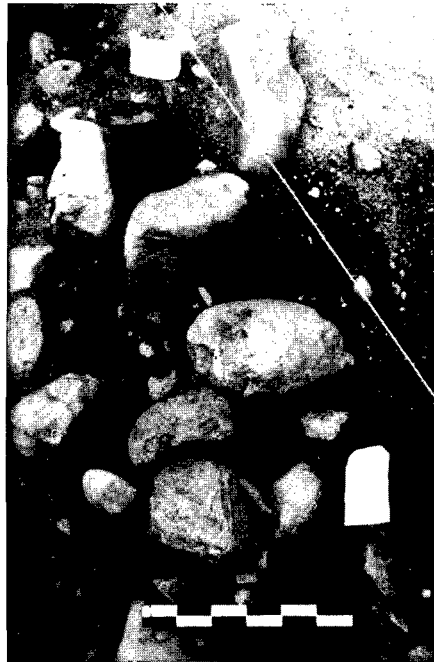
ILLUS 14 Detail of individual stone-wedged post-settings in palisade B

The eastern line of this second palisade consisted of 14 post settings over a length of 7.5 m, with an average gap of 50 cm, centre to centre, between the settings (illus 14). The method of construction was to cut a number of roughly 35 cm square holes through the summit lip to an average depth of about 40 cm. Next, the 20 cm to 30 cm square timbers were placed in these sockets, and packing-stone wedges hammered in (illus 8, section U). Palisade B may have been stronger than the earlier version and would certainly have been strong enough to support a wall-walk if required. Tentative evidence for this was found in the form of two postholes and one post-pit, and a linear slot adjacent to the east palisade (dimensions on table 5, group 8, fiche 4: C5). The 1 m long beam slot (181) adjoined the palisade to the S of the two settings (182) and the very nature of this setting and the other (262),

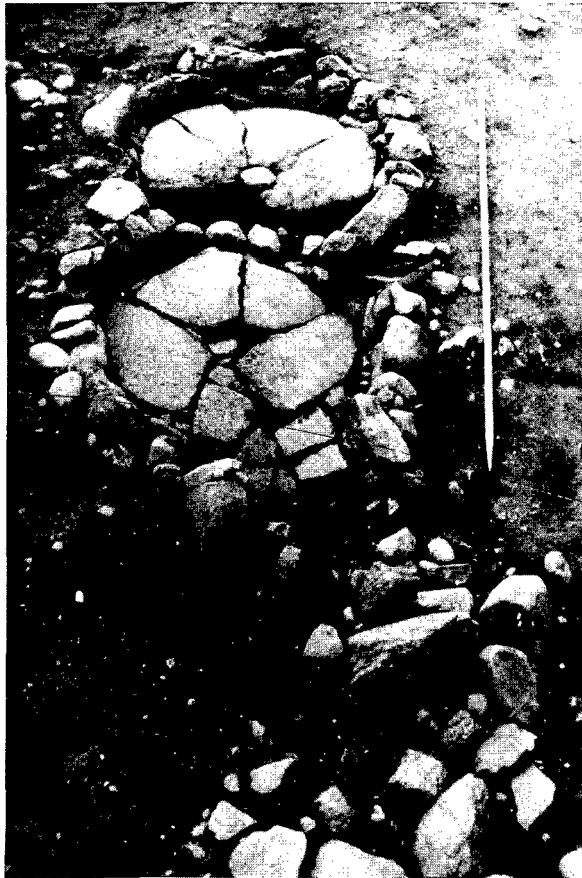
ILLUS 16 Furnaces 45 and 47

After what may have been only a few years, the furnace in the preceding phase was replaced by an identical model (45) situated at the northern base of the platform, some 6.5 m NW of the first. This was found in a better state of preservation, with a more complete millstone base of the same diameter as the first. Situated 2.5 m E of this and resting on the same level as the furnace was an associated spread of medium and large, partially shaped, granite blocks (79). These may have originated from the demolition of the oven furnaces, although it is more likely that they represent a dismantled structure, possibly a water cistern used in conjunction with the third furnace (illus 16).

This second structure was soon replaced by the third, constructed on top of the flue of the former. This furnace (47) was constructed in exactly the same way as the others, with a slightly smaller fragmented millstone base, surrounded by three surviving courses of freestone granite standing to a height of 60 cm. The flue continued this stonework into an E-facing, parallel-sided channel 35 cm in length and 40 cm in width. It was partially floored with heat-cracked granite blocks, with none surviving where the fire would have been at the east end. No associated structural features were found, such as stakeholes for branches forming a clay-dome framework. Apart from the evidence of burning on the stones, hardly any associated burnt sediments were found, indicating that the furnaces were regularly and thoroughly cleaned out.

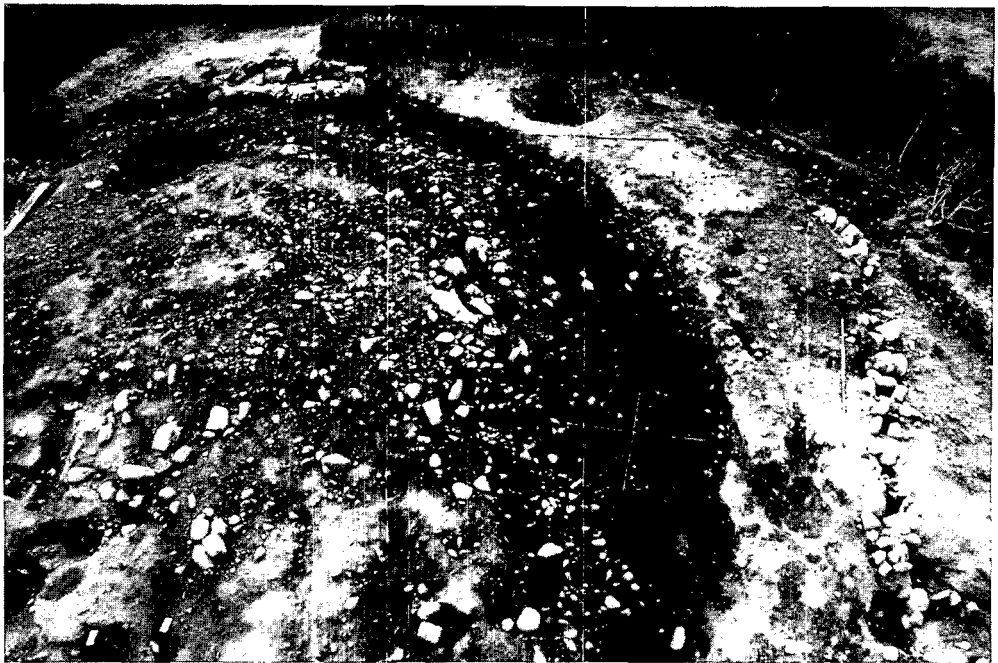
ILLUS 17 Midden 43, palisade B with excavated slot 260 and hall interior

(illus 17). The colour was partly derived from a high content of crushed charcoal, from both domestic fires and the furnaces. An identical deposit found on the north-eastern motte slope represents the same material flung beyond the palisade, and running down into the ditch (illus 6), section E). This sealed the earliest furnace and partially sealed the second one which was replaced contemporaneously with the building-up of the midden. Many lumps of daub in the form of burnt clay with grooved and flat impressions were found in this layer.

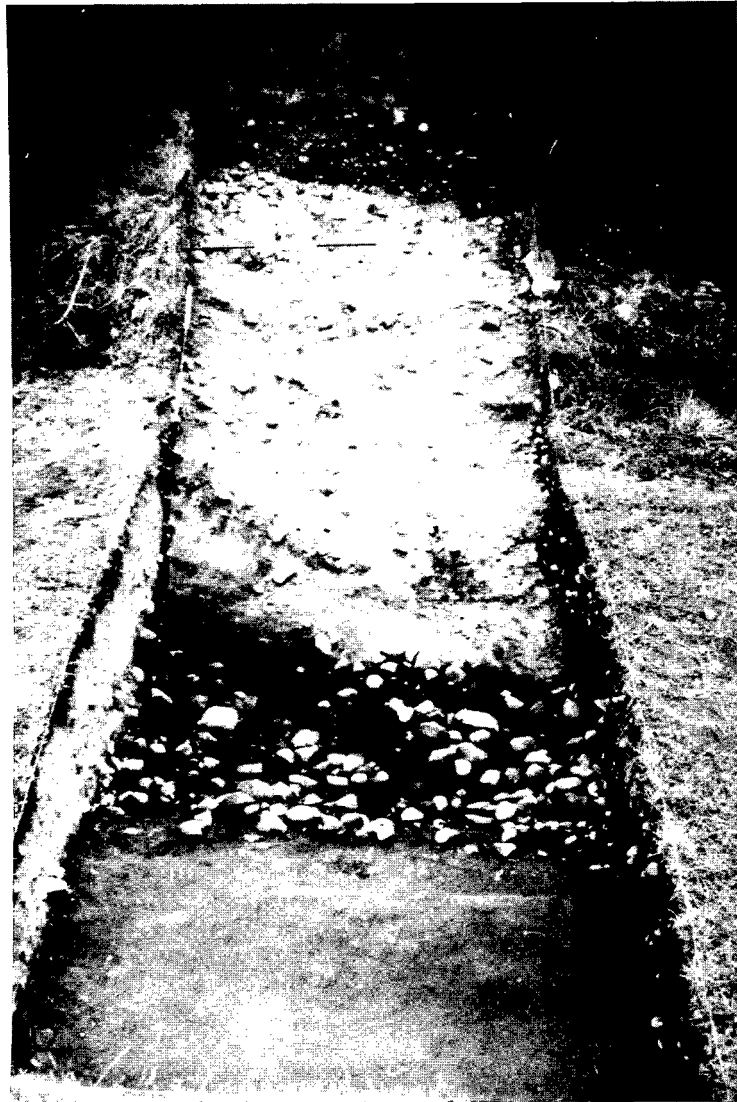
ILLUS 20 Area III ditch with revetment collapse

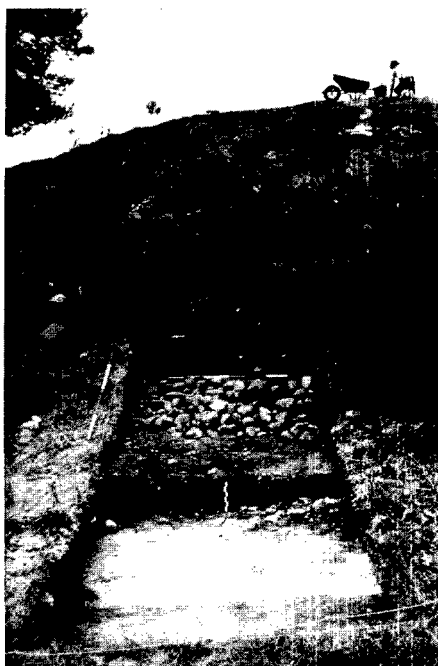
ILLUS 21 Area II revetment wall with drainage cut 110 in foreground

Granite freestone, found in the lower fillings of all three excavated ditch lengths, originated from a collapsed revetment wall built around most, if not all, of the motte base (illus 20). Only in Area II did the wall survive, where it was found standing to a height of 70 cm in five courses (351), set 1 m to the W of the inner drainage cut. The amount of associated tumble suggested that the wall was originally over 1 m in height, and may have been further heightened with turf to contain the loose, heaped-up gravel behind. The large stones found in Area VIII on the slope above the inner ditch were also remains of this wall. After settling and consolidation had taken place, the revetment would not have been required and appears to have been allowed to fall into disrepair before the motte was abandoned (illus 21).

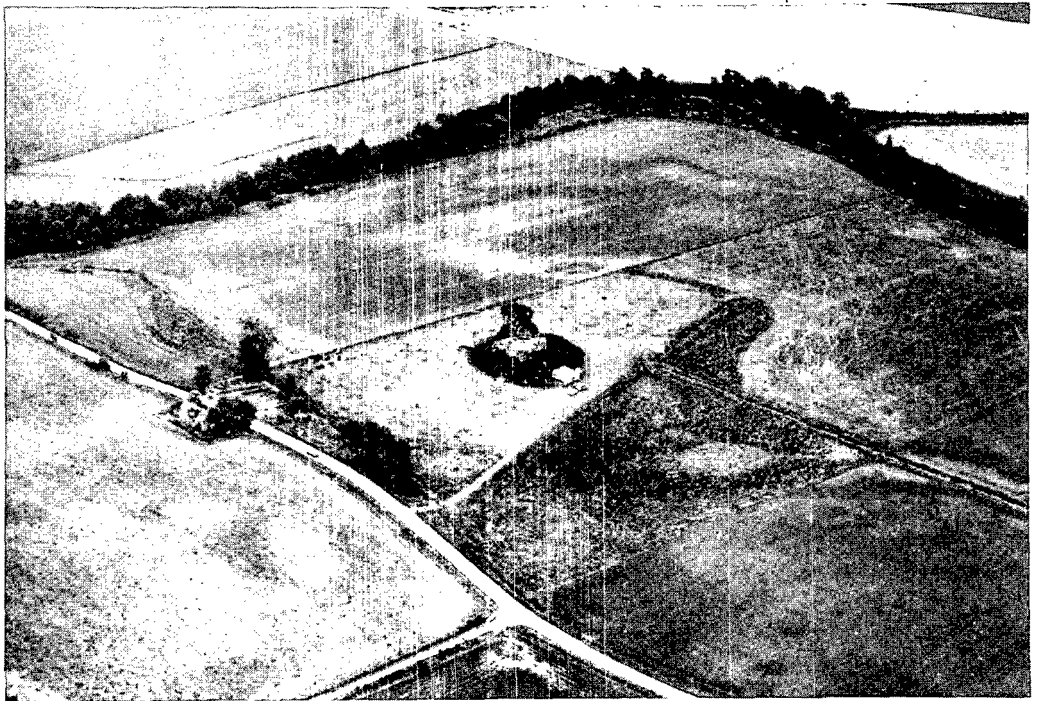
ILLUS 30 Aerial view showing former drainage pattern (Aberdeen Archaeological Surveys: Crown Copyright reserved)

The conclusion of the research carried out is that the depression cutting across the valley floor to the south of Castlehill of Strachan (illus 30) marks the line of a former course of the river Feugh.
